Steam Mill Road

Road Safety Audit

Muscogee County, Georgia

Stantec Consulting Services Inc. (Stantec)

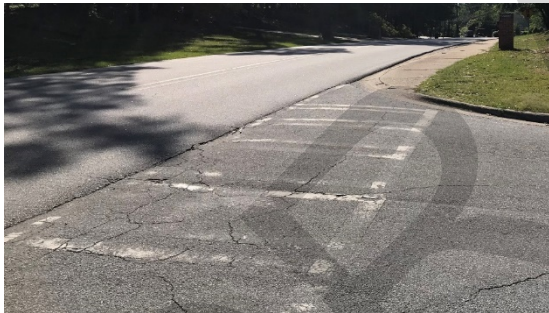
Faded crosswalk at Chandler Drive intersection

In many locations along the corridor, crosswalks, stop bars, and other striping are faded or incomplete due to repaving.

Consider restriping markings along the corridor using either High-Build Paint or Thermoplastic, which is more reflective. This will better delineate the centerlines, edge lines, stop bars, and crosswalks during low light conditions. These materials also have a longer lifespan, so the new striping would not have to be replaced as frequently.

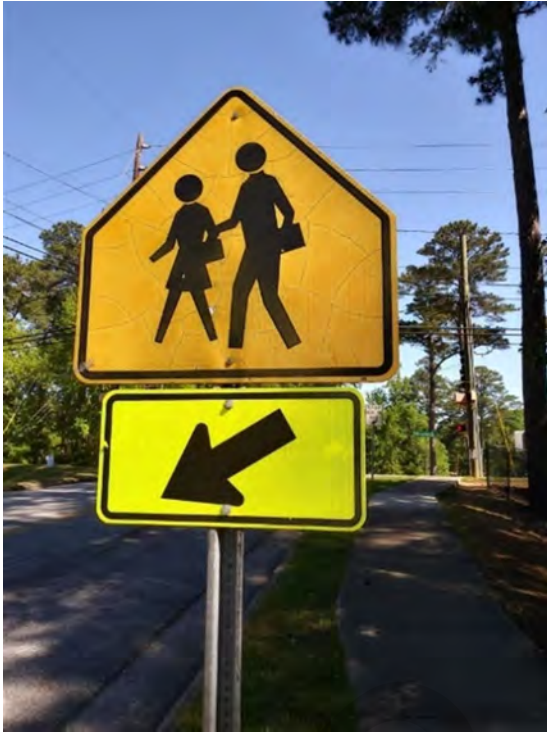
Old School Crossing Sign at Southern Pines Drive/McCartha Drive Intersection

Along the corridor, signs were spotted which do not conform to the standards set in the Manual on Uniform Traffic Control Devices (MUTCD). There are old, faded signs with poor retroreflectivity as well as signs which are mounted below the MUTCD recommended heights or with incorrect offsets from the travel way.

Consider replacing these faded signs with new signs made of MUTCD approved materials. These newer signs have better retroreflectivity for visibility in low light conditions. Additionally, consider replacing these signs with new signs mounted at the MUTCD recommended heights. This should improve visibility and put them at a safe height for pedestrians.

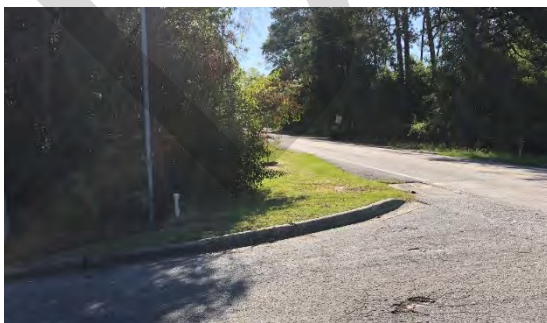
Vegetation blocking view at Cross Creek Apartments Driveway

At various points along the corridor, vegetation has grown to a point where it hides signs from view or reduces sight distance at intersections

Consider removing vegetation that blocks signs or reduces sight distance at intersections and driveways.

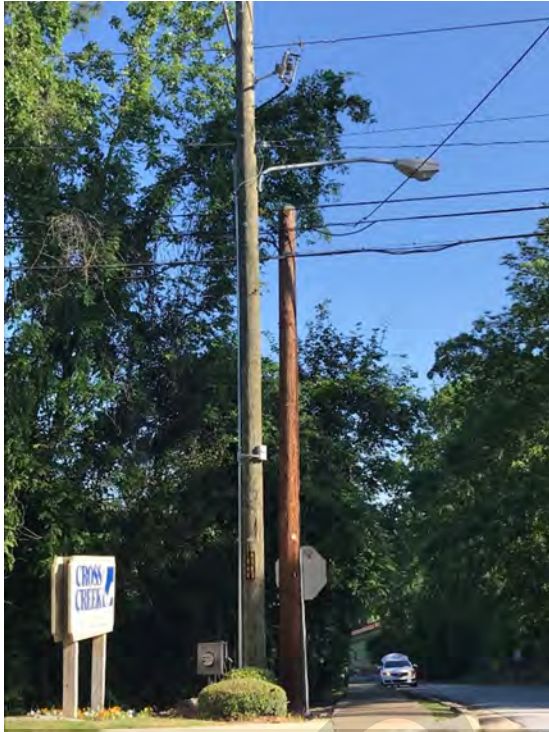
Streetlamp above sidewalks at Cross Creek Apartments driveway

While streetlamps are located along the corridor, their spacing and overgrown vegetation has limited their effectiveness in lighting the roadway and sidewalks.

Consider installing shorter streetlamps at shorter intervals alongside pedestrian facilities for the entire length of the corridor. Shorter streetlamps with a closer spacing will provide pedestrian lighting that will make pedestrians more visible to motorists and make pedestrians feel safer.

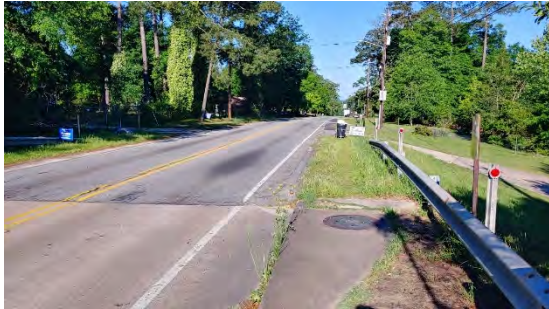
Sidewalk terminates at the western end of the I-185 overpass

Sidewalks are lacking west of the bridge over I-185. East of I-185, sidewalks are present on one or both sides of Steam Mill Road until Timberlane Drive.

- Option 1: Fill in sidewalk gaps along the corridor, particularly west of the I-185 overpass bridge to provide pedestrian facilities to Buena Vista Road. This would remove the need for pedestrians to walk in the grass alongside Steam Mill Rd.
- Option 2: Construct a 5-ft sidewalk on the northside of Steam Mill Road from Buena Vista Road to Pinecrest Drive. This sidewalk should be offset at least five feet from the roadway. If this sidewalk is to be incorporated into the Complete Streets Corridor Redesign, then offset this sidewalk by twelve and a half feet so that this sidewalk does not need to be reconstructed.
- Option 3: Construct a 5-ft sidewalk on the northside of Steam Mill Road from Buena Vista Road to Pinecrest Drive. Build Curb and Gutter for the length of Steam Mill Road and offset the new sidewalk from the curb by three feet.

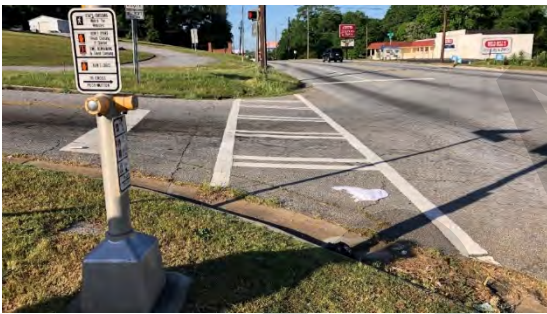
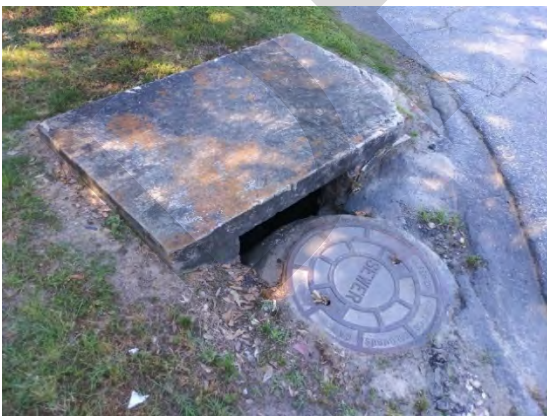
Crosswalk without connecting ADA ramps or sidewalks

- Skew of east leg of intersection is dangerous, which may contribute to the large number of collisions reported at this intersection.
- Crosswalks are present across the eastern approach of the intersection, but there are no sidewalks or ADA ramps for these crosswalks
- Just east of the Mission Columbus driveway, there is a large drainage structure which is near enough to the roadway that it has clearly been struck by vehicles in the past.

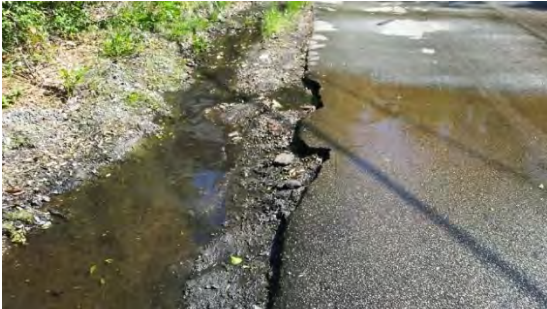
Drainage issues on the northern leg of Fair Oaks Dr

- Fair Oaks Dr
 - Safety Opportunities Pointed Out by Stantec
 - Standing water and poor pavement condition on the northern leg of Fair Oaks Dr.

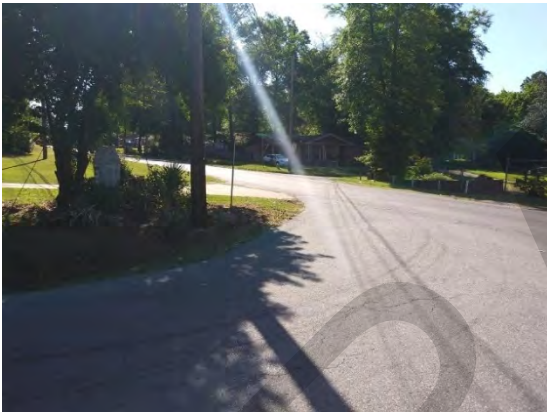
View blocked by vegetation looking east from northern leg of Fair Oaks Drive

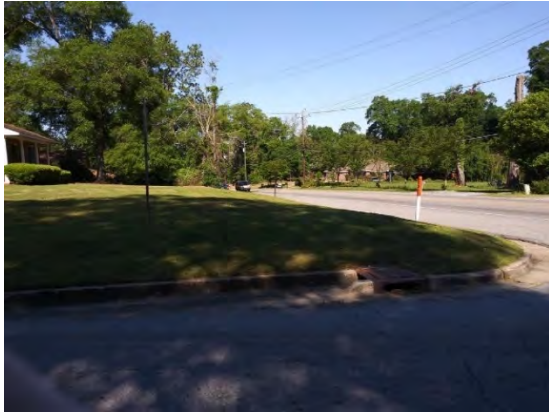
Low visibility looking west from Honolulu Drive

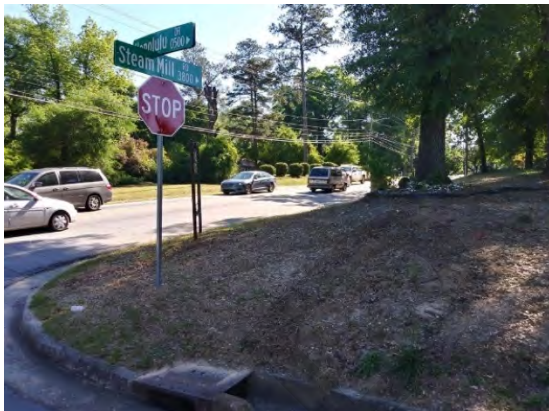
Low visibility looking east from Honolulu Drive

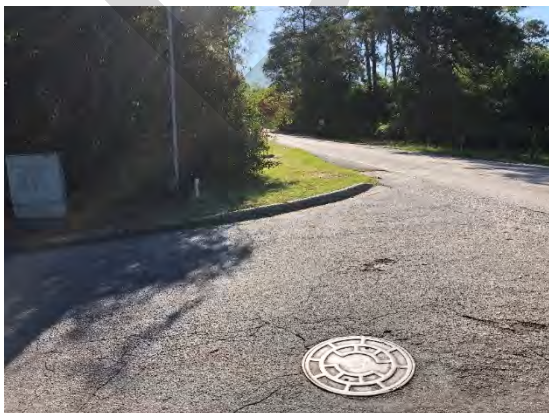
Low visibility looking east from Cross Creek Apartments Driveway

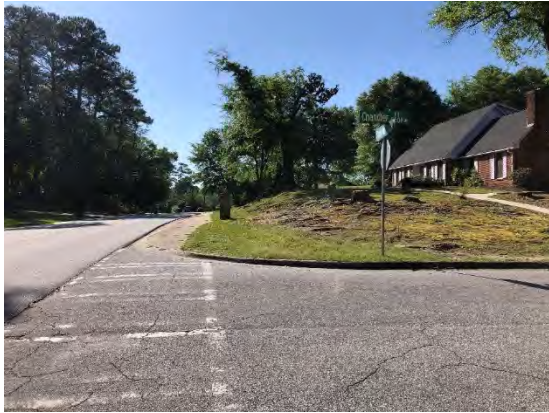
Lack of stop bar at Chandler Drive approach

Consider adding a stop bar for the Chandler Dr approach.

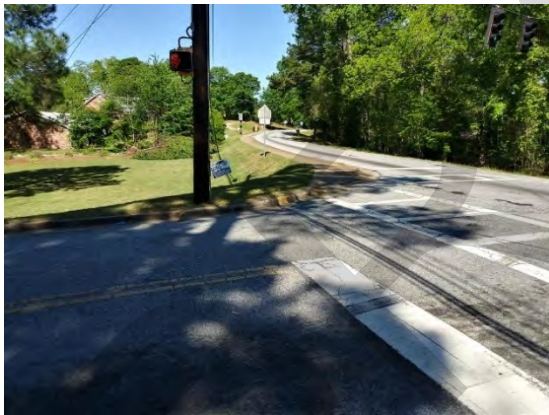
Drop off behind sidewalk on the southwest corner

- The signal poles and signal cabinet all appear to be within the clear zone.
- The north and south legs drop away sharply as they leave the intersection. The crosswalk across the north leg is not visible from the south leg and vice versa. This is especially concerning at this location since the elementary school is located at this intersection.

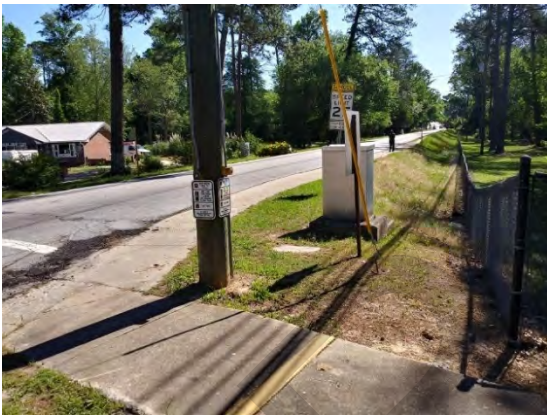
Signal pole and cabinet on the southeast corner of the intersection

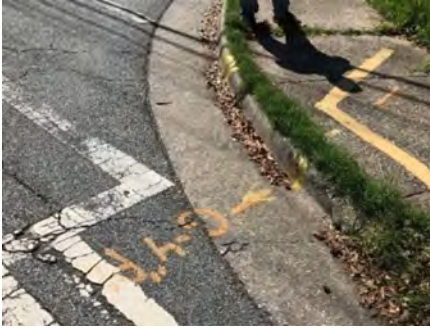
Corner of intersection without ADA compliant curb ramps

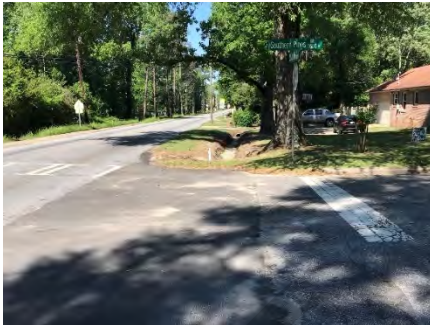
Northwest corner of intersection with no receiving sidewalks or curb ramps

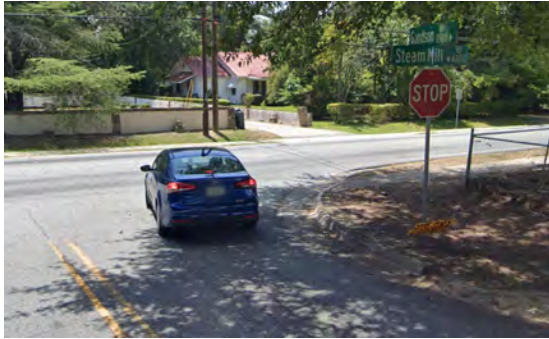
Goodson Drive approach to Steam Mill Road

- Consider adding a thermoplastic stop bar to Goodson Dr approach.

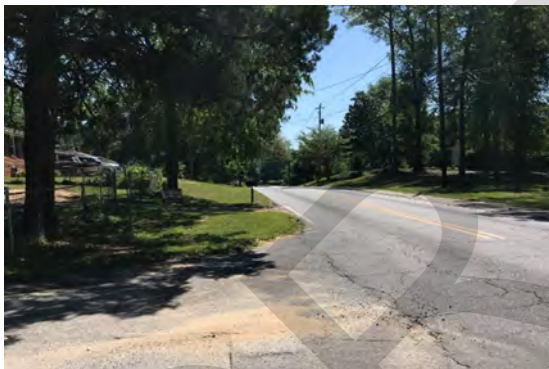
Eastward view from Englewood Drive blocked by crest

- There is a crest east of Englewood Dr that creates a sight distance hazard for vehicles entering/exiting Steam Mill Rd. This crest may have played a part in one of the fatal collisions which occurred along this corridor by blocking the vision of an EB vehicle turning left from Steam Mill Rd onto Englewood Dr and another vehicle heading west on Steam Mill Rd.

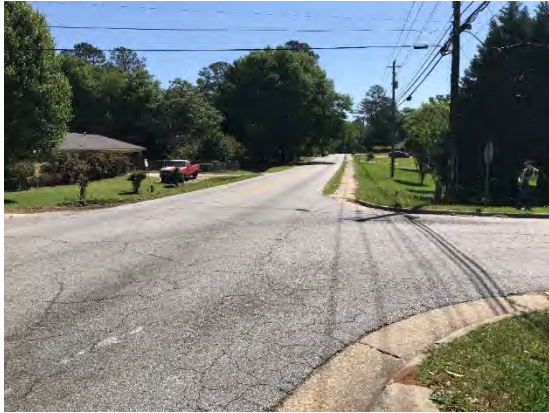
Wickham Drive approach without stop bar

- Missing stop bars at the north and south approaches to this intersection.

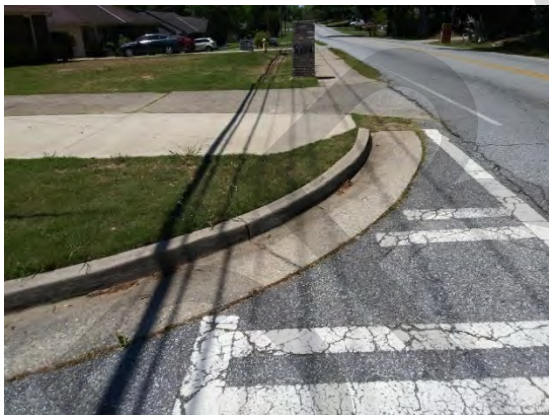
Southwest corner of intersection without curb ramp

- Missing stop bar at approach.
- Due to presence of driveways at each corner, there are no ADA compliant curb ramps for the Steam Mill Place approach.

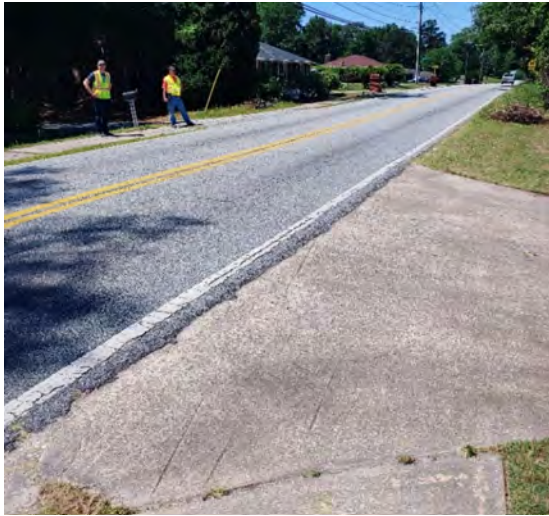
Sidewalk terminating at first driveway west of Georgia Dr

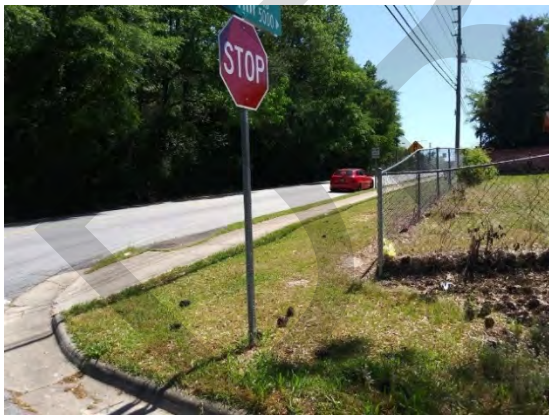
Stop sign placement and street parked car at Mt. Pleasant Drive

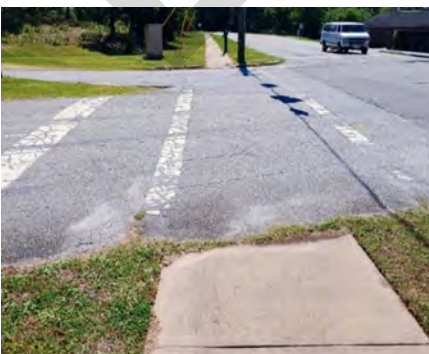
Curb ramps across Shirley Winston Park Driveway without ADA warning surfaces

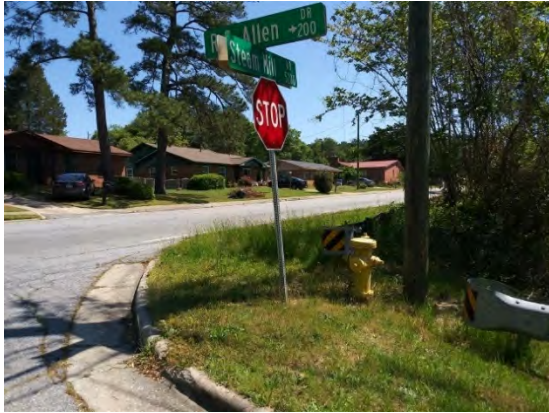
Stop sign placement at R.C. Allen Drive

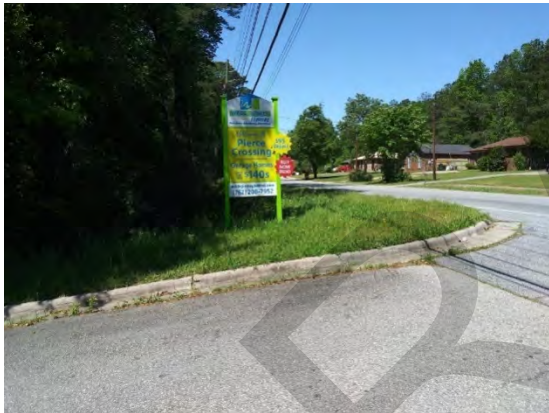
Large realty sign west of R.C. Allen Drive

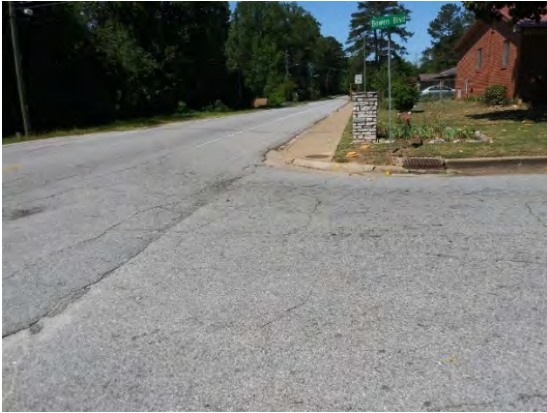
Bowen Boulevard approach without stop bar

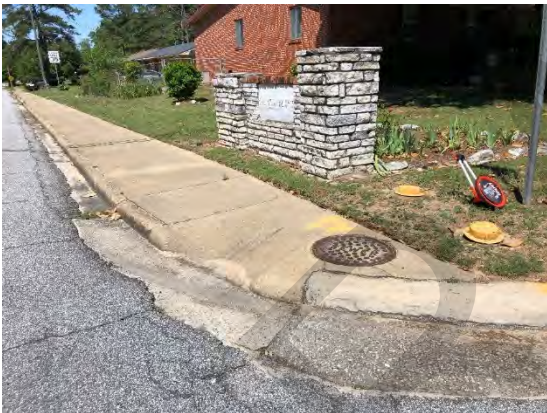
Curb ramp angled toward Steam Mill Road at Bowen Boulevard

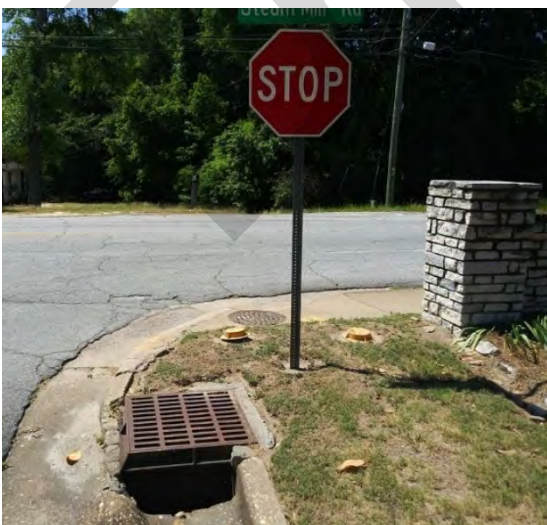
Drainage structure which reportedly floods during storms

- Lack of hardscape facilities
 - Drainage structure with sewer manhole at its mouth
 - Mitchell observed that if the sewer manhole prevents this drainage structure from operating properly that it could lead to crashes being caused by hydroplaning.

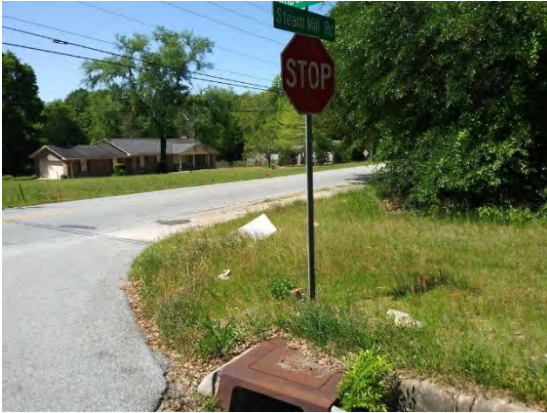
Placement of stop sign at Timberlane Drive
