Steam Mill Road

Road Safety Audit

Muscogee County, Georgia

Stantec Consulting Services Inc. (Stantec)

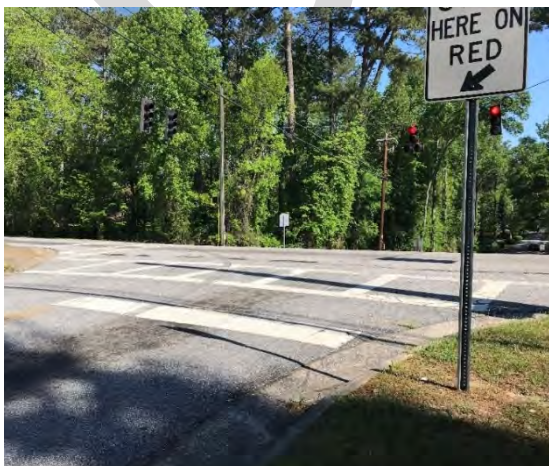
View looking north from southern leg

- The signal poles and signal cabinet all appear to be within the clear zone.
- The north and south legs drop away sharply as they leave the intersection. The crosswalk across the north leg is not visible from the south leg and vice versa. This is especially concerning at this location since the elementary school is located at this intersection.

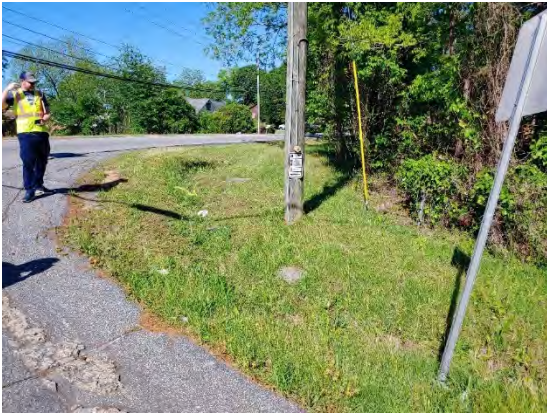
- The pedestrian signal buttons on the northwest corner, where there is no sidewalk, is a few feet away from the pavement behind a grass ditch, making it difficult to access.

Pedestrian signal buttons on northwest corner of intersection

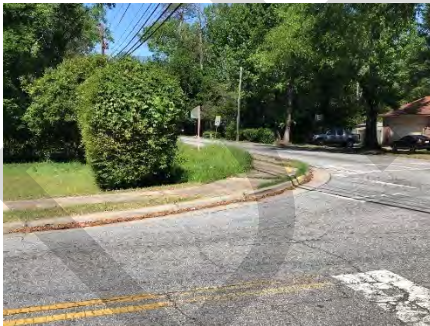
Westward view from south leg of intersection

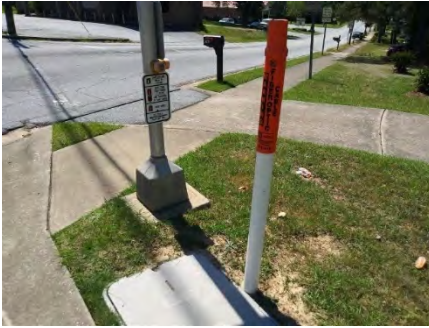
Pedestrian signal buttons on Southwest Corner

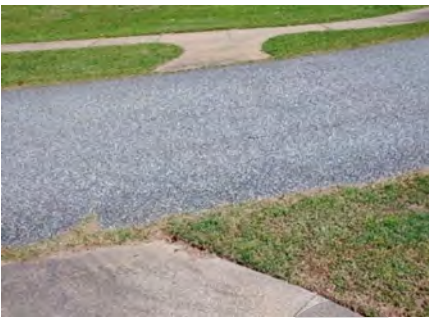
Crossing of right turn lane without crosswalk

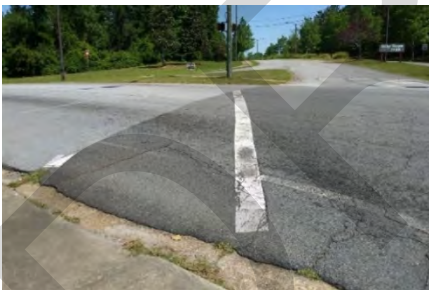
Crossing of western leg without receiving curb ramp or sidewalk
